**Project:**  
Monitoring The Mechanics' Institute

**Solution:**  
Trimble S6 DR robotic total station

## Case Study

# Monitoring The Mechanics' Institute

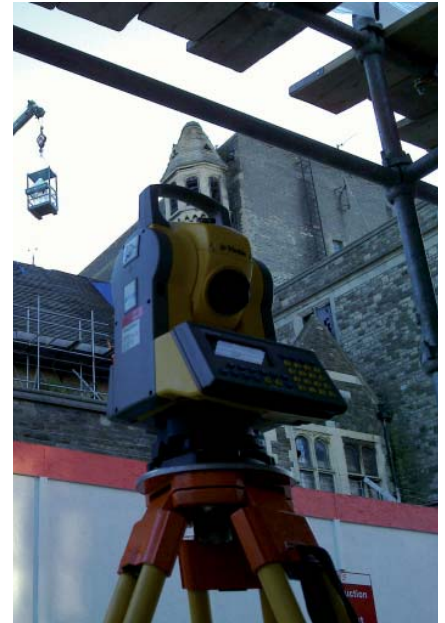
▲ Protected from wind and rain

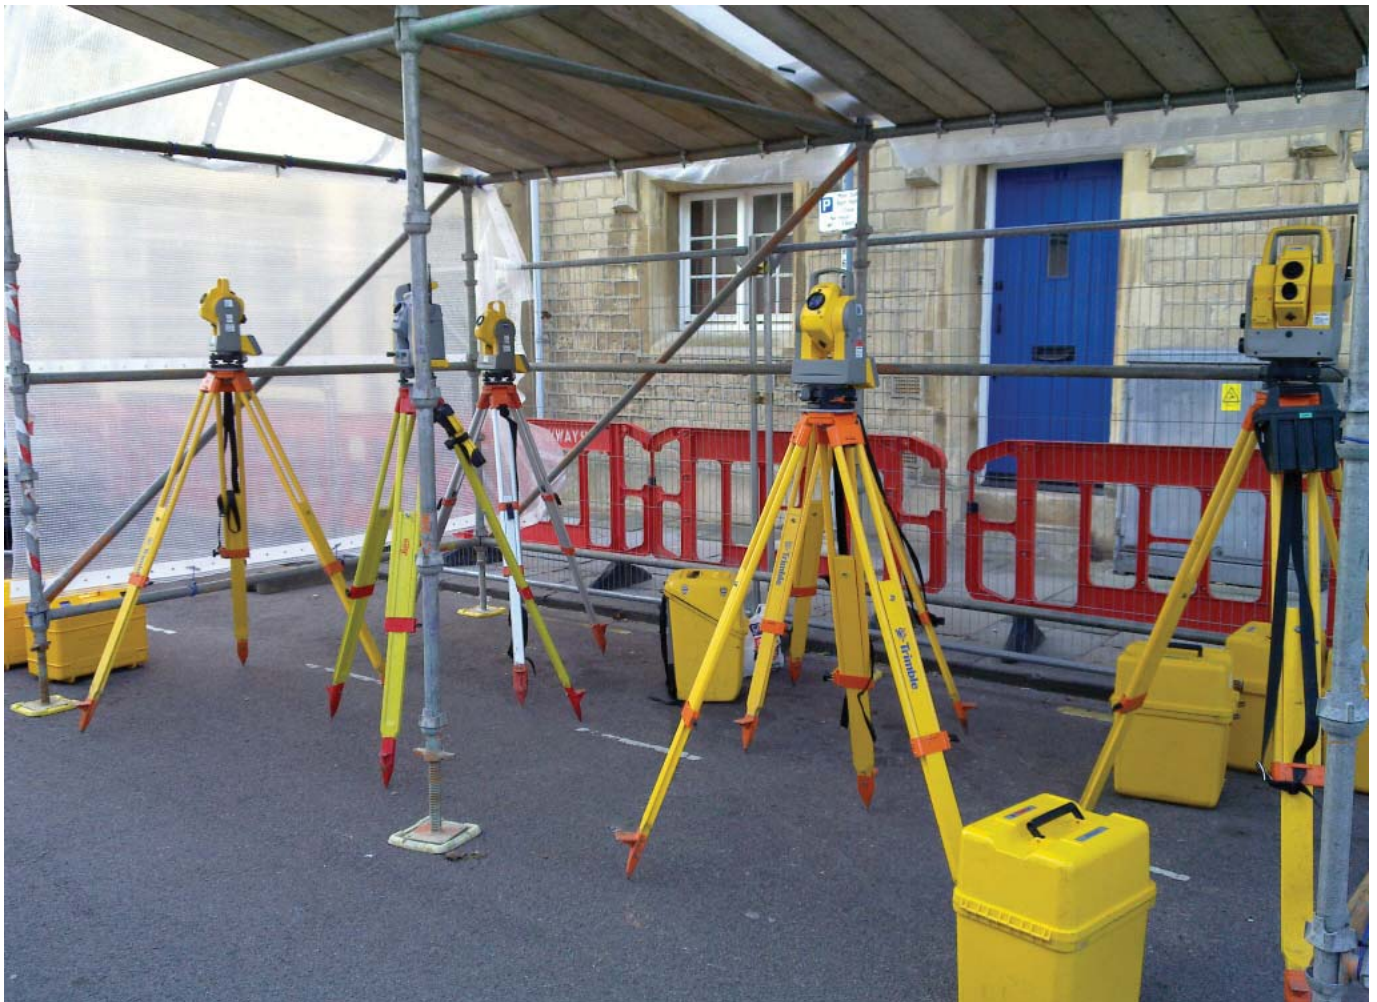
▲ Six KOREC supplied Trimble Total Stations were used

Despite our trepidation, the roof actually rebounded and became more stable as the process continued so by the final three days we had reduced our instrument usage to just the S6, conventionally monitoring every few minutes and continuing with our a.m. and p.m. readings to cover us overnight. The Trimble S6 really came into its own during the final few days. Manually we could type in an angle

and it was a simple process to use the "Turn to" function in the software and check each of the six targets every 15 minutes with just the S6. We were constantly checking back to a reference shot to ensure there was no angle slip and the S6 was always spot on which meant that we had total confidence in the results we were getting.
